Research Journal of Agriculture and Biological Sciences, 4(3): 251-256, 2008 © 2008, INSInet Publication

# Impact of Non-point Pollutants on the Physicochemistry of Orelope Stream, Onabamiro, Ago-iwoye. Southwest Nigeria

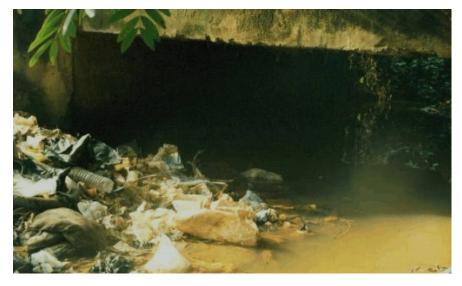
Fig. 1: Sampling site A of Orelope Stream (The pond formed by the impoundment of the stream)

This observation is a good indicator of a stream that is highly loaded with nutrient with the suitable physicochemical parameters for eutrophication and ecological succession taken place gradually at the stream (Fig1), especially in the area where the dumpsite is located (Fig. 3). **Conclusion:** It is evident from this study that increased population density of Ago-Iwoye and the resultant poor land use planning, as well as lack of adequate hygienic infrastructural facilities and waste disposal units has considerable influence in the contamination of Orelope stream.

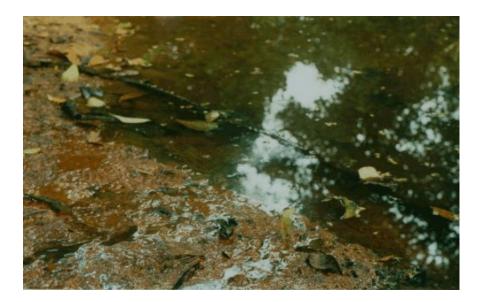
Fig. 2: Sampling site B of Orelope Stream showing a non-point pollution

**Discussion:** Though the result of this study showed that the pH, Total dissolved solids(TDS) of the stream at all sampling points were within the acceptable limits of World Health Organization<sup>[13]</sup> standard, the color of the water, which is light brown indicated that the stream is unclean (Fig 2, 3 and 4) and contaminated with impurities.

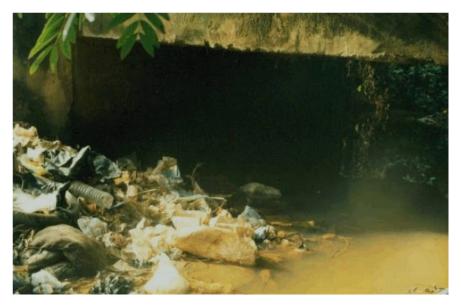
Fig. 3: Sampling site C of Orelope Stream (the point adjoining the dumpsite)

The value of COD (667 mgL<sup>-1</sup>) and BOD (256 mgL<sup>-1</sup>) at sampling point C of the stream were higher than that obtained at sampling points B and C (Table 2). The higher BOD and COD obtained at point C indicate the presence of large amount of organic matter, which was as a result of the dumpsite located here. Wastes from this dumpsite have greatly encroached into the stream at this point (Fig 4).
